## 0.1 Overview

User spilled tonic water on a laptop, then kept it powered on and continued to use it (this was a mistake. Turning it off, and removing battery / power, letting the liquid dry, is always the first step in a spill). The next morning the laptop would not power on.

Laptop is an HP Pavilion 15 CS model. They are fairly new (date codes on micros are from 2018), and retailing around 500-600 dollars as of just before

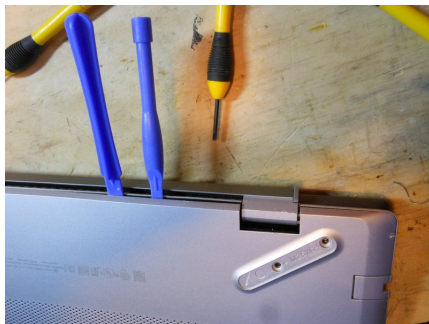
Figure 2: Disassembly

- Where to start with the spudger, and also showing the screwholes underneath the rubber feet.

There is no video tutorial on this online, but the steps are: Remove visible screws from the back of the case. Remove rubber feet, and screws beneath them. Pry open case from edges with plastic spudger tool to remove the clips. You must be careful, as the clips and case are fragile.

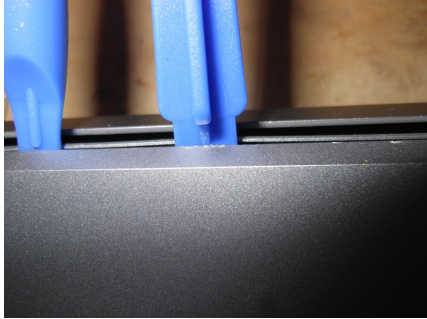
Figure 3: Disassembly

- I was able to scratch the case with the plastic spudger. Be careful!

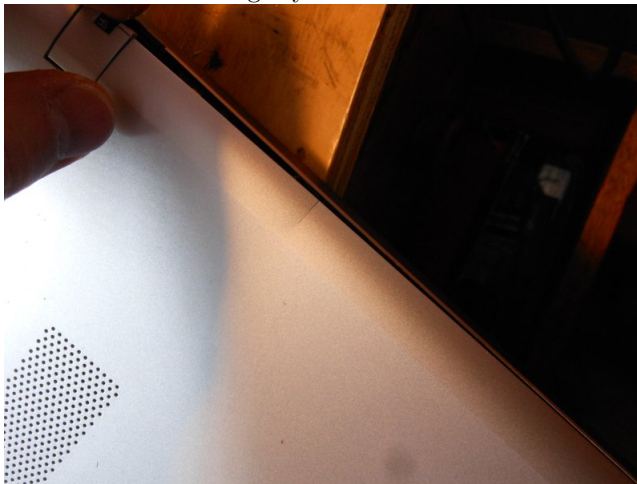
Figure 4: Disassembly

- The case can also crack from pulling it. I didn't pull this hard, but the brittle weak case cracked slightly.

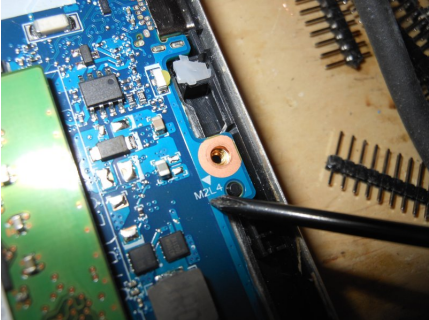
Figure 7: Disassembly

- Screws are labeled, to help illustrate what size each is:

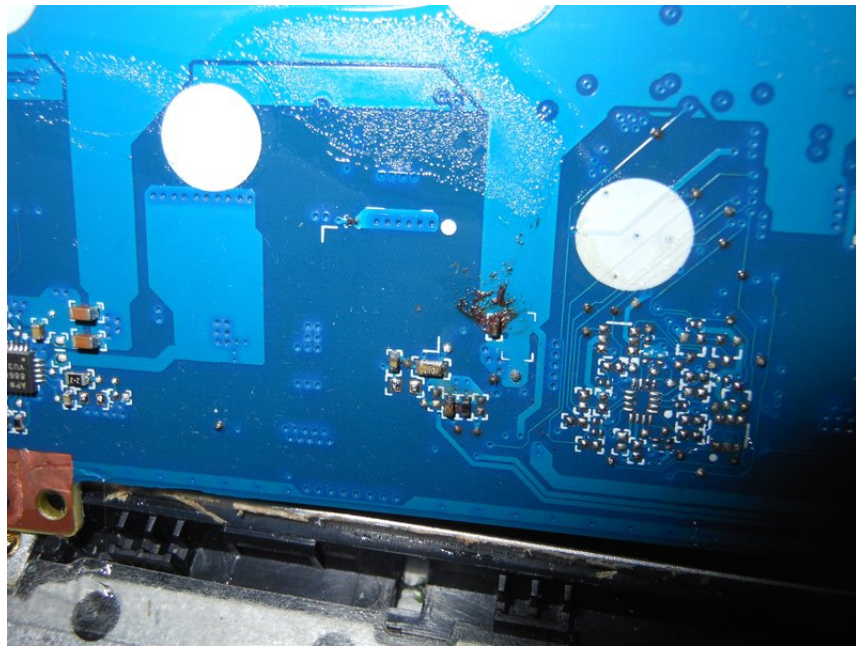
Figure 8: Repair

- Right away I can see some visible marring from a likely shorted component. This is where a lot of the soda residue is.

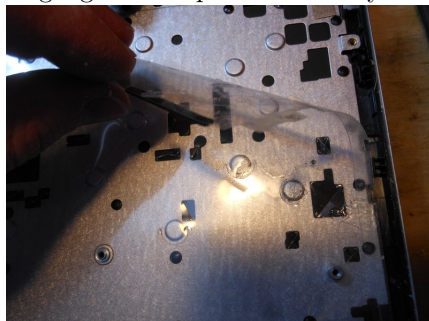
Figure 9: Repair

- You can see a layer of cellophane that is in place to protect against spills. Amazing how millions of man hours can go into designing computers, yet a single glass of liquid can destroy one. Something is wrong, here. Crazy.

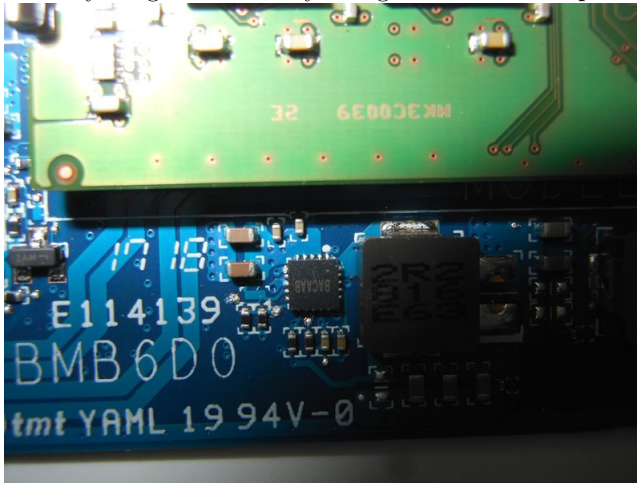
Figure 10: Repair

- This switcher, the BACAAB (?) chip is the one that has the failed components. I need a replacement but can't find a data sheet on it. I tried probing at some of the pins to see what was going on, and if I could understand a bit more about this, but due to me probing too close to the pins, (and a few factors, primarily the small package, but no leads, and also the fact I should've used the pads NEAR but not ON the package, I shorted something, and a spark resulted. While I saw a 2.4V signal on a pin, after the short, I was unable to find anything. The battery being removed and replaced did not bring it back.

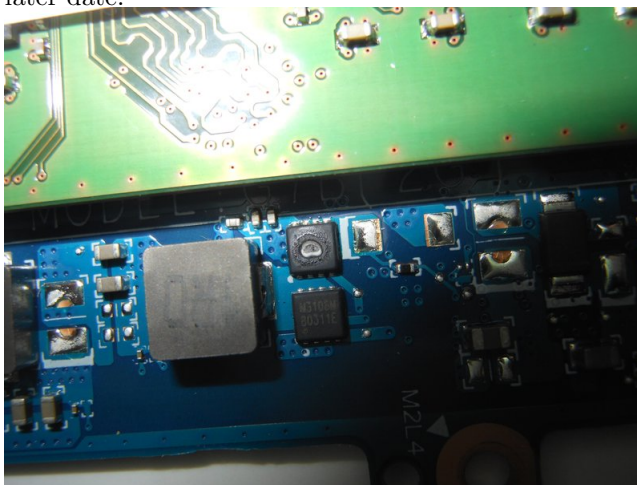
Figure 11: Repair

- At this point, this chip, which I am unsure of what it is, appears to have a short and is overheating / shorting. I will need to get a motherboard donor at this point, to further repair the mistakes. As these are new boards, motherboards are not yet cheap enough to make this viable, so I will wait and try again at a later date.

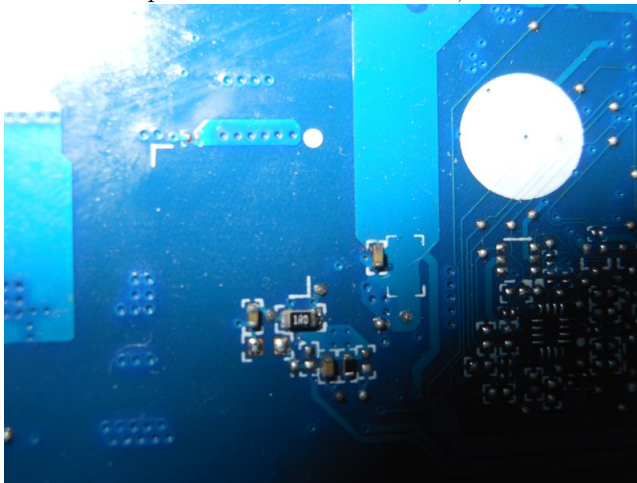
- During my troubleshooting, I did find an open resistor, and a capacitor that has visible charring on its solder joint. I'll need to replace these as well. I should've replaced this at first, but without a schematic, I don't know what value the cap should be. The resistor is labeled as 1R0, but reads open. There may also be one other cap that has failed. However, some other components appear OK.

Figure 12: Site of failed components from soda water spill.
