1 Harbor Freight Bauer Drill Repair

1.1 Overview

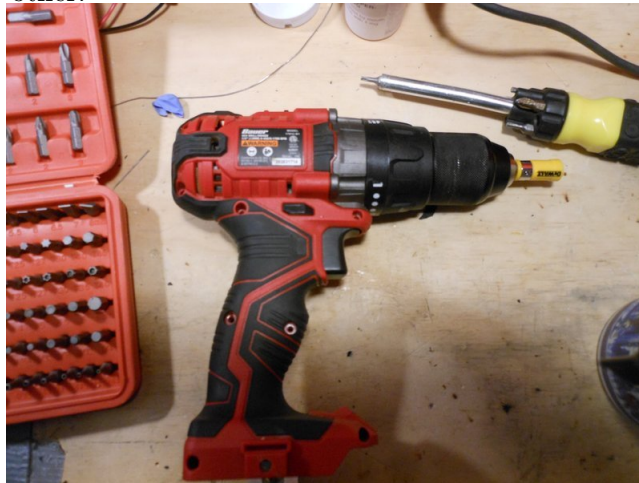
I was using the drill when it failed. Not in any excessive capacity, instead simply using the drill, moderately. I began to smell something burning, but the drill continued to work. After another moment, the drill was completely failed. What had happened, is that one of the DPak FETs had failed, then the other.

Figure 1: This style seems to be the current favorite (techy red and grip, with a square lithium pack). A trip to the hardware store will reveal other brands with similar looks as of 2018.

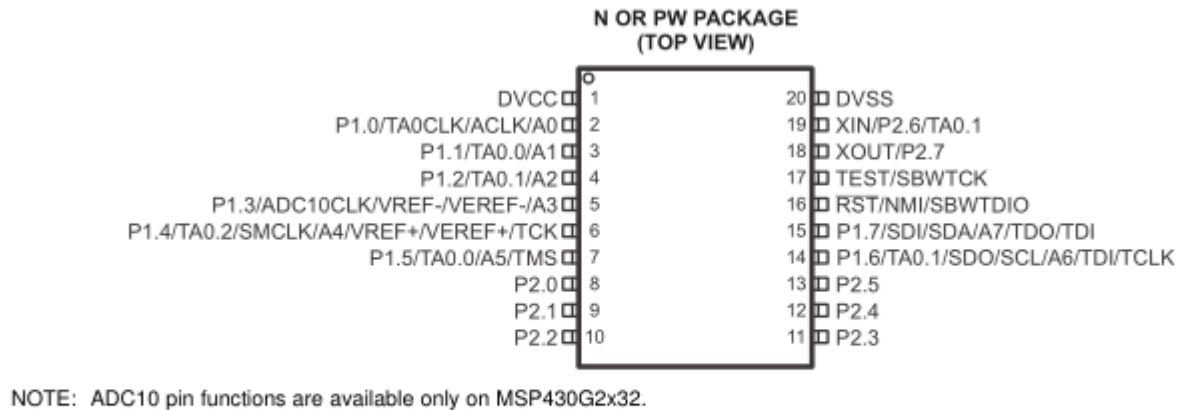
Micro is TI msp430g252. ¹ Question is, what is the level of the voltage regulator? Is it 20V? It appears to be an onsemi model such as: CS52015 I can't find an exact match from Digikey which only searches current models, not historical models.

Figure 2: Pinout for MSP430

Checking the pins of the msp430 with a scope, I can see it has a sleep mode, a pin to control gate, a pin to control LED. I thought I saw UART, but it's just a CLK input. Led is two or three to the left. There also seems to be some pin, maybe adc monitoring drill (top, right side pin).

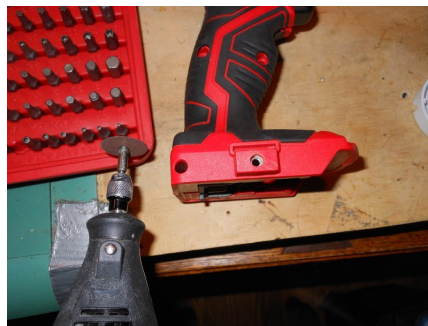
Figure 5: A dremel was used to help open the drill up, as I had not the required bit to open it (It required a longer torx driver than I had, so I opened up one of the drill inserts slightly).
