1 Harbor Freight Bauer Drill Repair

1.1 Overview

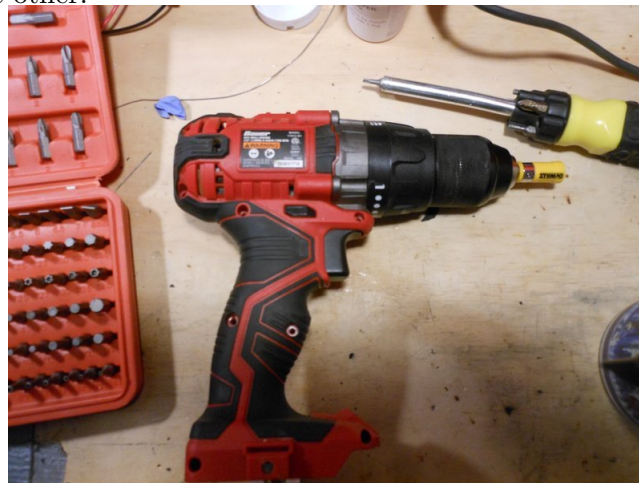
Figure 1: This style seems to be the current favorite (techy red and grip, with a square lithium pack). A trip to the hardware store will reveal other brands with similar looks as of 2018.

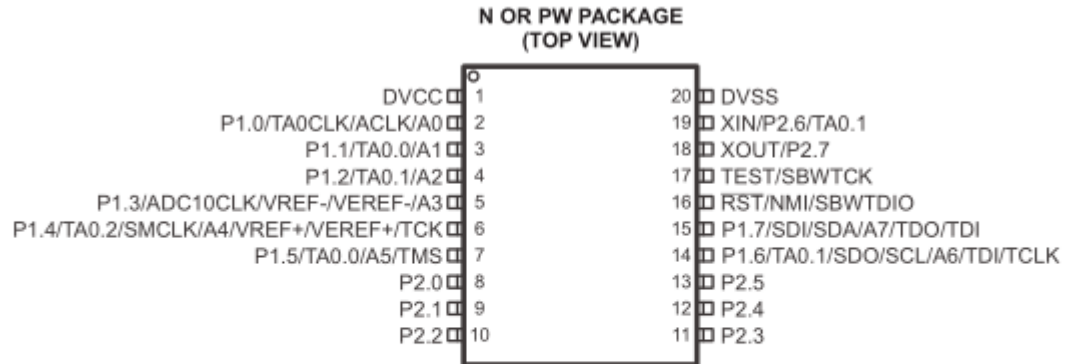
Figure 2: Pinout for MSP430

Micro is TI msp430g252. ¹ Question is, what is the level of the voltage regulator? Is it 20V? It appears to be an onsemi model such as: CS52015 I can't find an exact match from Digikey which only searches current models, not historical models.

NOTE: ADC10 pin functions are available only on MSP430G2x32.

Checking the pins of the msp430 with a scope, I can see it has a sleep mode, a pin to control gate, a pin to control LED. I thought I saw UART, but it's just a CLK input. Led is two or three to the left. There also seems to be some pin, maybe adc monitoring drill (top, right side pin).
