HP Pavilion 15 Repair

Steak Electronics

1 Overview

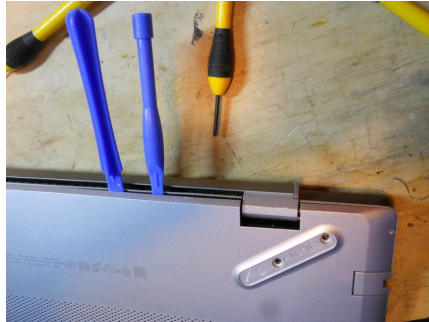
Figure 2: Disassembly

- Where to start with the spudger, and also showing the screwholes underneath the rubber feet.

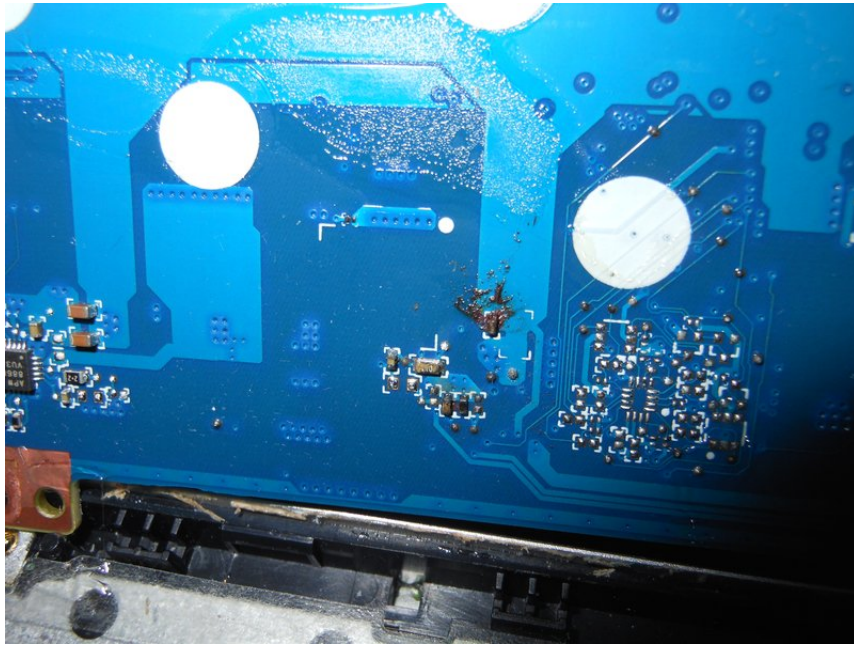
Figure 8: Repair

- Right away I can see some visible marring from a likely shorted component. This is where a lot of the soda residue is.

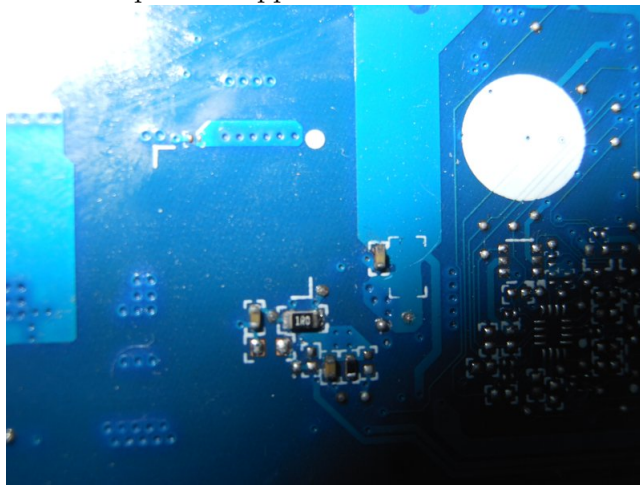
- During my troubleshooting, I did find an open resistor, and a capacitor that has visible charring on its solder joint. I'll need to replace these as well. I should've replaced this at first, but without a schematic, I don't know what value the cap should be. The resistor is labeled as 1R0, but reads open. There may also be one other cap that has failed. However, some other components appear OK.

Figure 12: Site of failed components from soda water spill.

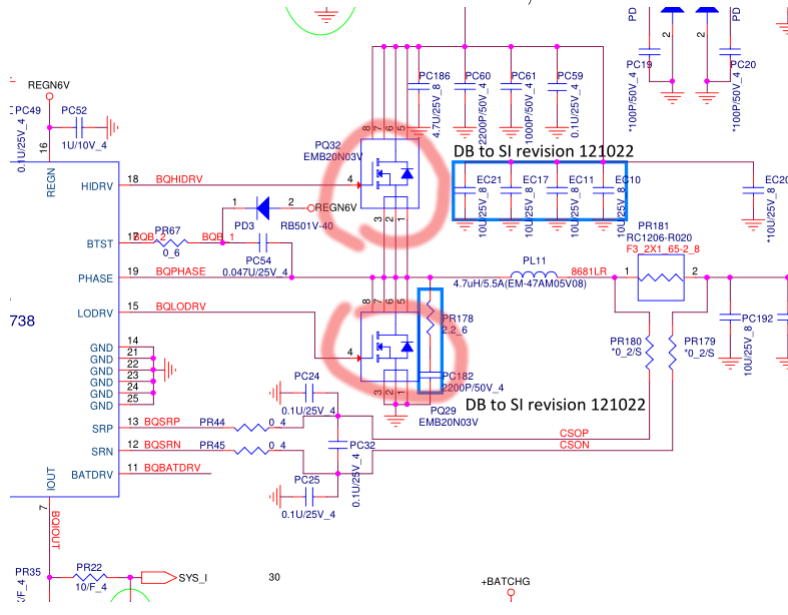
I burnt out one of the FETs after the original damage was done to a part¹, but luckily, there are two being used, so I was able to take the pin for pin identical (though lettering was different) mosfet and replace it. Looking at the similar schematic I have in resources, I think I should be OK.

Figure 14: Similar mosfets in this schematic...
