HP Pavilion 15 Repair

1 Overview

User spilled tonic water on a laptop, then kept it powered on and continued to use it (this was a mistake. Turning it off, and removing battery / power, letting the liquid dry, is always the first step in a spill). The next morning the laptop would not power on.

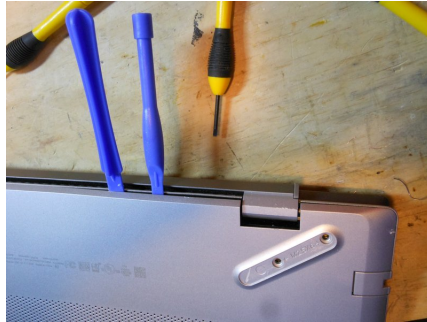
Figure 2: Disassembly

- Where to start with the spudger, and also showing the screwholes underneath the rubber feet.

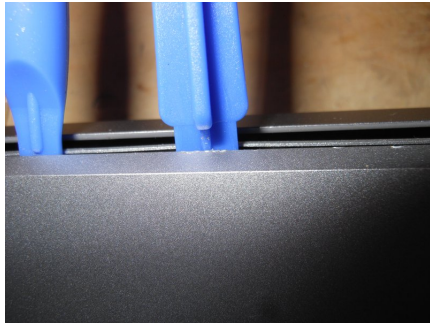
Figure 3: Disassembly

- I was able to scratch the case with the plastic spudger. Be careful!

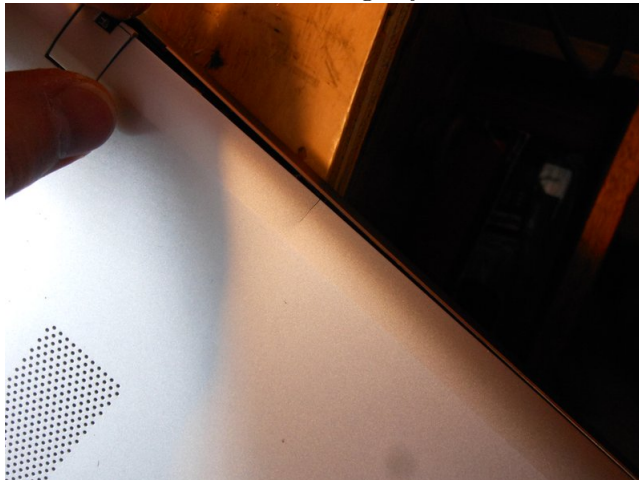
Figure 4: Disassembly

- The case can also crack from pulling it. I didn't pull this hard, but the brittle weak case cracked slightly.

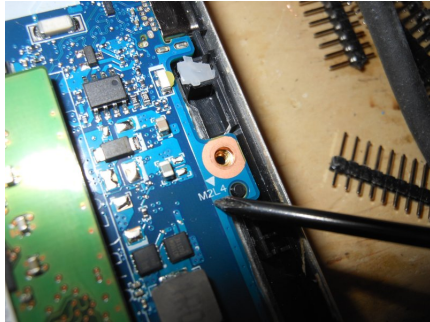
Figure 7: Disassembly

- Screws are labeled, to help illustrate what size each is:

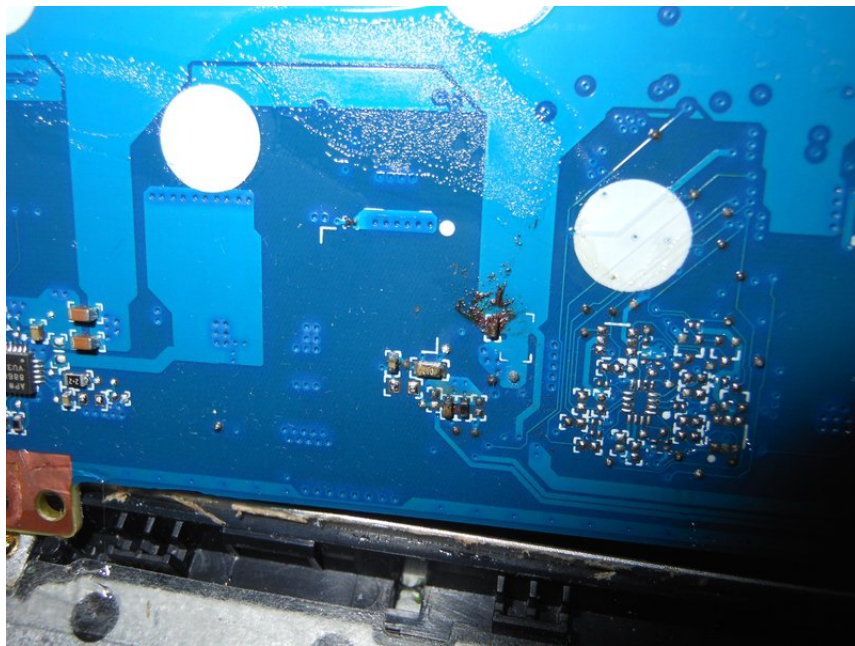
Figure 8: Repair

- Right away I can see some visible marring from a likely shorted component. This is where a lot of the soda residue is.

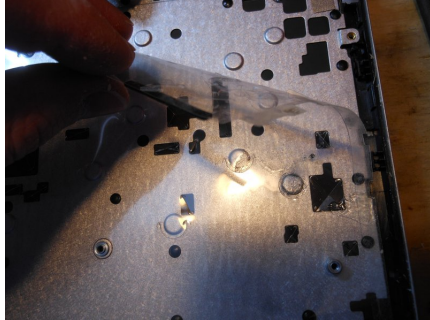
Figure 9: Repair

- You can see a layer of cellophane that is in place to protect against spills. Amazing how millions of man hours can go into designing computers, yet a single glass of liquid can destroy one. Something is wrong, here. Crazy.

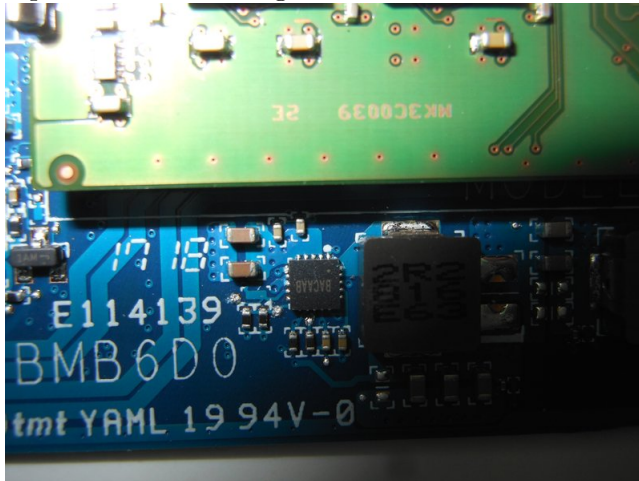
Figure 10: Repair

- This switcher, the BACAAB (?) chip is the one that has the failed components. I need a replacement but can't find a data sheet on it. I tried probing at some of the pins to see what was going on, and if I could understand a bit more about this, but due to me probing too close to the pins, (and a few factors, primarily the small package, but no leads, and also the fact I should've used the pads NEAR but not ON the package, I shorted something, and a spark resulted. While I saw a 2.4V signal on a pin, after the short, I was unable to find anything. The battery being removed and replaced did not bring it back.

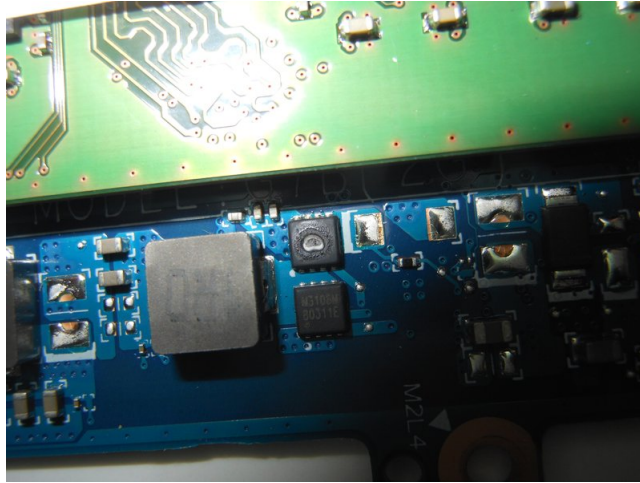
Figure 11: Repair

- At this point, this chip, which I am unsure of what it is, appears to have a short and is overheating / shorting. I will need to get a motherboard donor at this point, to further repair the mistakes. As these are new boards, motherboards are not yet cheap enough to make this viable, so I will wait and try again at a later date.
