# Sony PVM 14M4U Repair

Steak Electronics

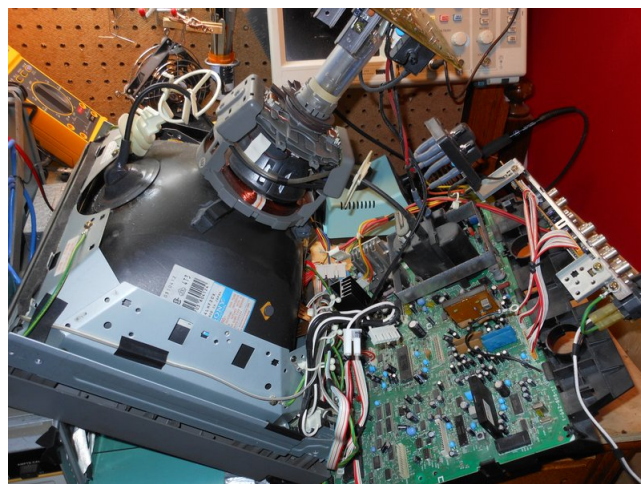
Figure 1: Barely User Service-able!

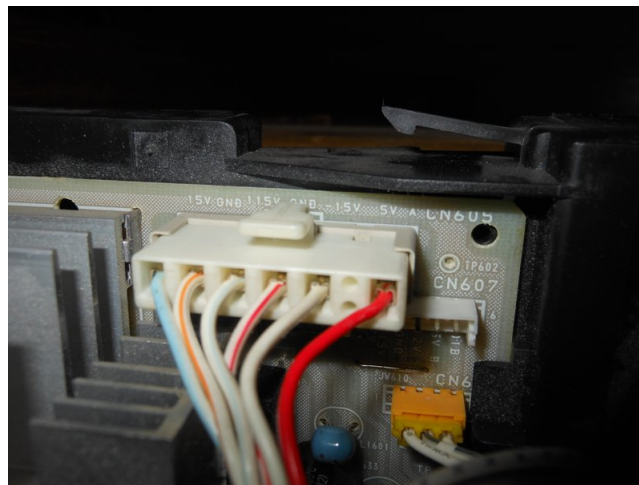
I poked around a bit, but after a few minutes, remembered that voltages should always be checked somewhere early in the repair. Lucky for me, a -15v voltage is showing -25 volts. It being a negative voltage (in my limited knowledge) points to it being for an op amp, and op amps that don't have the right voltage might fail the H and V sync. I will try to fix that and hope there is no other damage.

Figure 2: The Rail is listed as -15V...

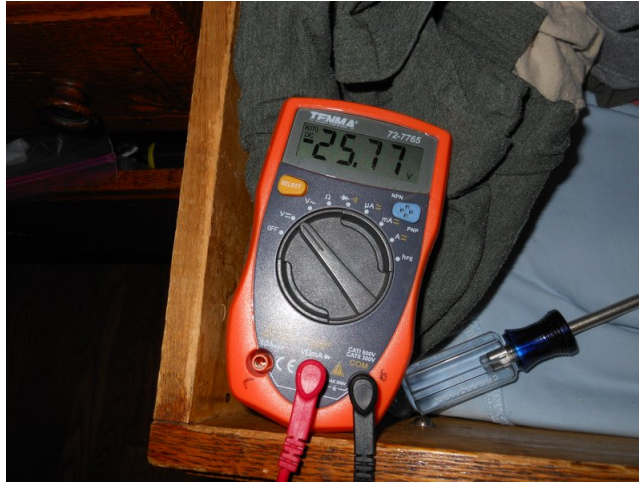
Figure 3: Fault. Later on I moved to a Fluke 27 for this, so please bear with the low quality DMM

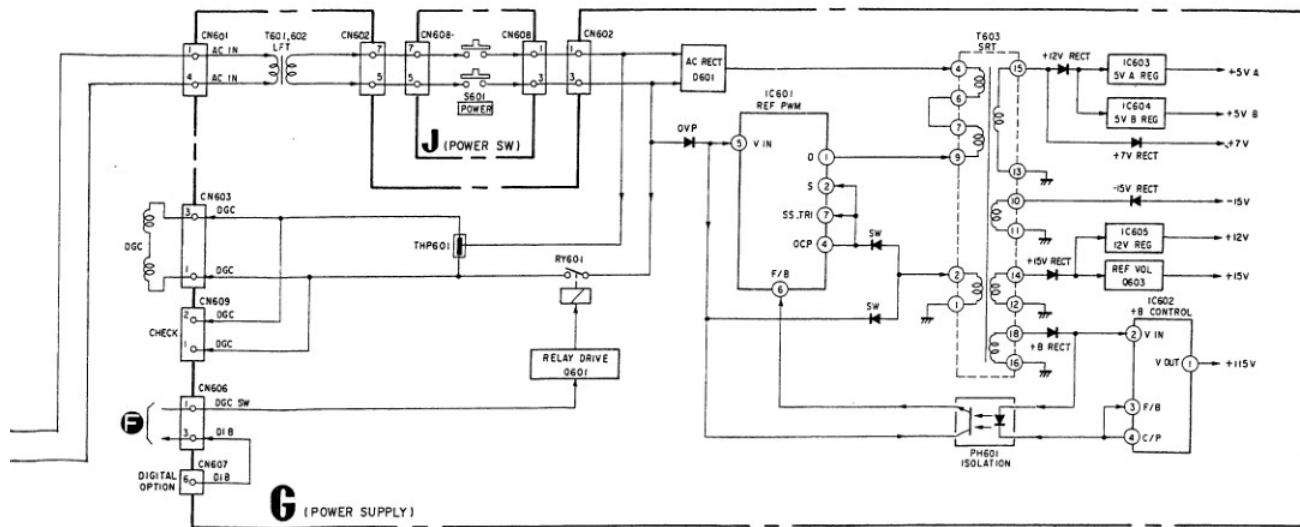
I looked around, and the output from the PWM is fed into a transformer, where it's rectified into a number of different voltages. The service manual tells all of this.

Figure 4: PWM to Transformer to Zener

It appears that the -15V rail (as well as the +7V rail, both have voltages slightly off. I thought at first, the diodes from the block diagram were

zeners (being backwards) but it looks like instead, the problem is before the transformer. I'll have to delve a little deeper to see what is giving an incorrect value.

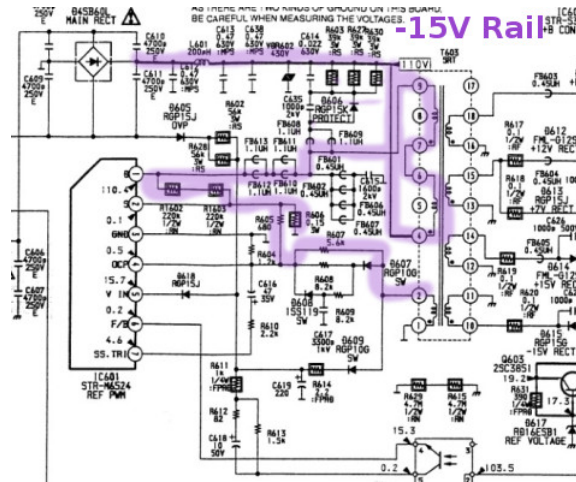
Figure 5: -15V Rail

R605 Measures 380, which may be right (due to it being on board when measuring. it IS close). R604 is .4K (390). Supposed to be 1.2K. But, measuring on board... R607 is .4K again. Seems measuring these in circuit is a losing game. C616 is not a short. R610 is 8.1K. Seems high. It's value should be no higher than 2.2K... Looks like this is a schematic error, as R608 and R609 are the same value resistors and both are similar readings. R610 is in spec. About all I can think, is pulling R604, R605, and R607 and measuring them.

I'm a bit confused whether the test probe measurements are AC or DC. It says 110, which is after a rectifier, (so DC) but I see AC also on this line, and as well, it's going through a transformer, so it must be AC that is coupling, but the AC is 22V, while the DC is 135V or so. Perhaps the fault is near the bridge diode, and with the coupling capacitors nearby... I tried removing them before, but I don't have equipment to test their values. I didn't see any shorts. I give up - I will put in the LM337 and call it a day.

What I know is that there are two rails that are off, the 7V and -15V rails. The 7V rail doesn't appear to be used. I've decided to add in an additional -15V regulator using an LM337, to output 1.5A of -15V. I tried adding another cap on C629, the one of two electrolytics on the -15V rail, but no difference. There are two paths the -15V rail takes in from the mains. One is from the PWM pin B, which has a resistor divider go to S and then down to the pin of the transformer for -15V. One of these resistors might be underspec.

I managed to get an LM337 tested and built up on perfboard. As I was soldering wires to the machine, (while unplugged) some caps discharged back into the 115 VOut of the STRS3115 chip as I accidentally moved the probe the wrong way. Oops. Too bad there wasn't a diode there. Now the chip won't output 115V DC. Upon turning the Television on, you can hear the tube attempt to start (sounds like a high voltage ping, which fails to complete, then repeatedly pings - see video). Not enough voltage.

Good news is, a new chip should fix the 115V rail. There is nothing else on that rail that would've failed (although I can't speak for downstream), so a reasonably straightforward fix. The Television remains on the bench another few days. And some more good news, the LM337 seems to output a near clean -15V. It will be interesting to see what the repaired voltage rail does to the tv output once the 115V rail is back in order.
