CL Repair Bose Cinemate

Objective: Find out why Bose speakers don't work. User reports possible lightning surge caused damage to device.

Bose Cinemate 1

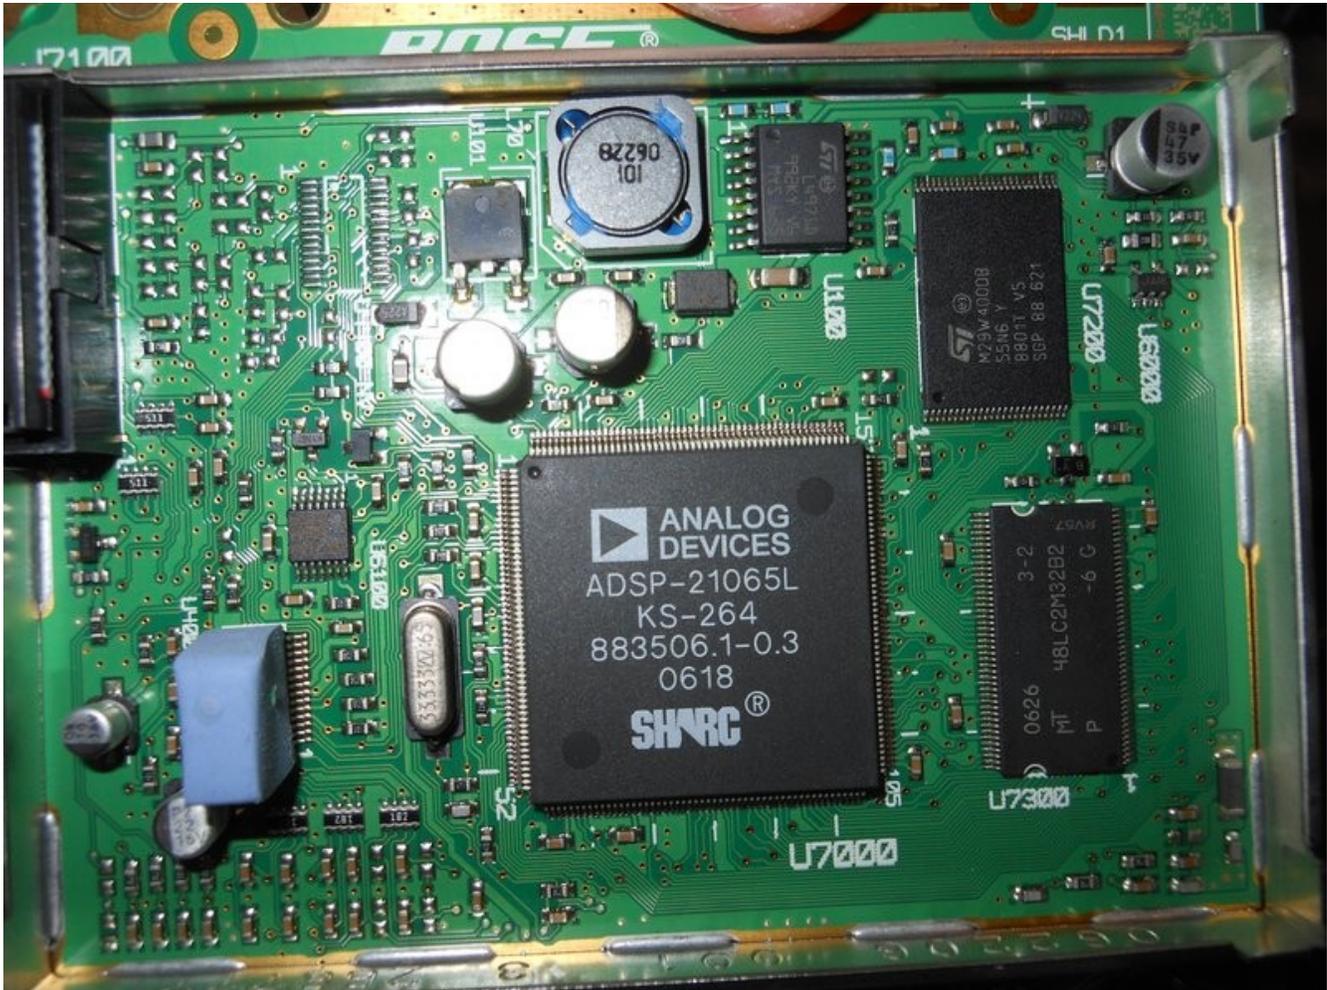
Main CPU board under can. Starting from 12 o'clock going clockwise, Linear and Switching power regulator, Flash, RAM, ADSP CPU (SHARC), ADC (under blue).

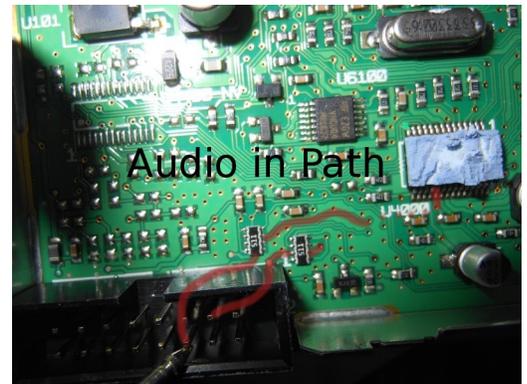
signals are fed into resistor dividers, one for each signal. From there they go (see picture) . From there the audio signal goes into that mysterious package, that has no label on it. Probably some ADC. EDIT: I can barely make out it is a Cirrus Logic chip. CS422BA
CS4228A

ADC/DAC with logo visible. CS4228A
