# Car Transmission Repair

Steak Electronics

## 1 Work Log

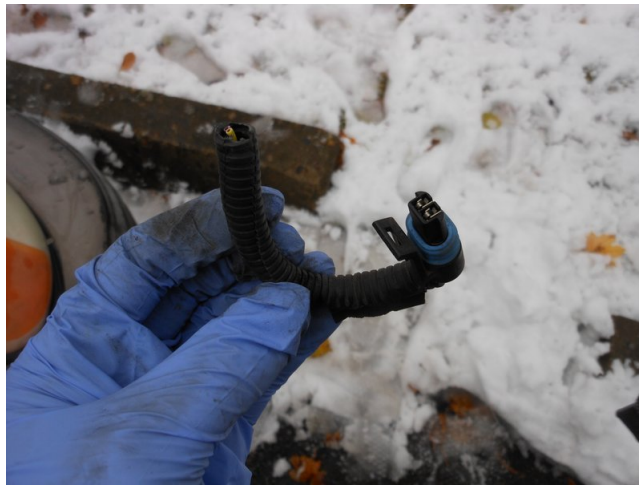
Figure 1: Cut off the connector at one end, so I can attach wires to it. This is what connected to the transmission

Since the wires were broken, it was simply an issue of having a portable soldering iron, and some solder. I brought the iron down to my car, adding some additional wire on, and soldered both ends. A trivial job for an electronics-wise fellow.

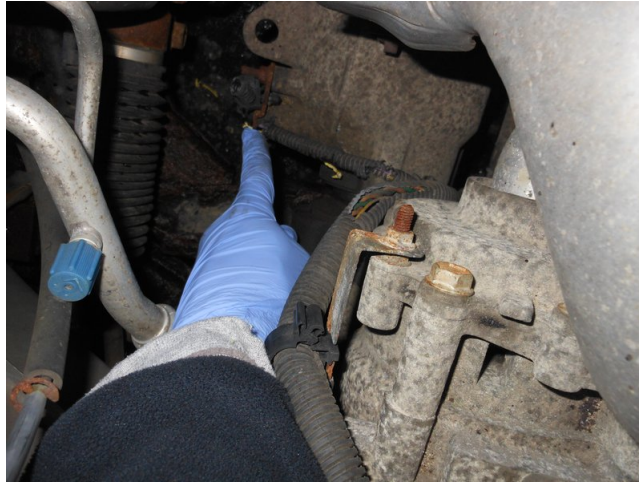
Figure 2: Wires visibly chewed here

The bunny had chewed up two of the wires. What happened, is that two sense wires to the transmission had failed, and as a result, the car was unable to control the transmission. A mechanic later implied that animals chewing wires was not uncommon. I was even fortunate enough to run into a bunny stuck in the car. Perhaps I caught him in the act.

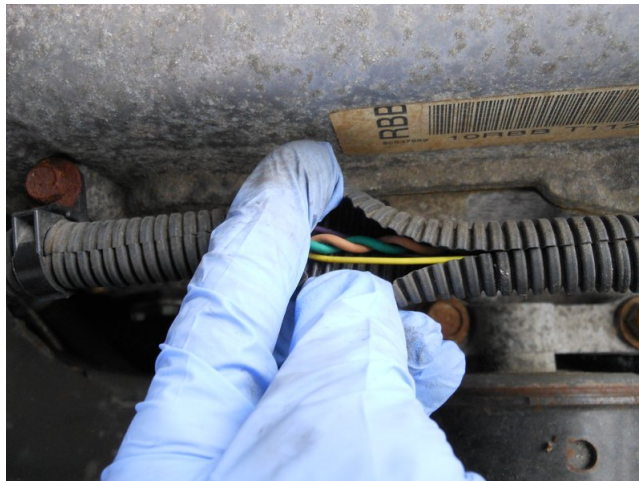
Figure 3: Further up the wire sleeve, where the wires are not chewed. Here I can cut them and solder new wires in. There are four wires here, as the sleeve was used for multiple wires.
