Sony PVM 14M4U Repair

Steak Electronics

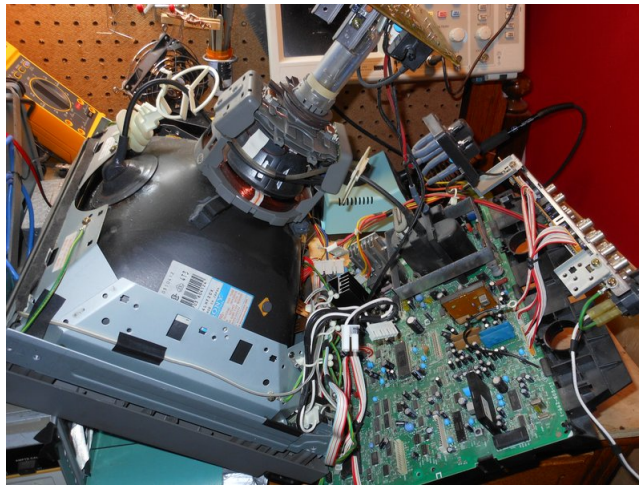
Figure 1: Barely User Service-able!

The second problem, which was more of a problem at the start, was disassembly, and then putting it in a way that it could be repaired. Video from bot-net tube (Sony PVM-8041Q Monitor Teardown and Repair-iyJDam0blYA) Shows a repair of a smaller 10 inch model, and you can see, the user is able to easily access parts of the board to repair. However, the 14 inch models are not as simple. The board with all the processing on it (the A board), is on the bottom of the chassis, and to take that out... well video 1104.webm shows what I had to do to get access to the board, while it's powered on.

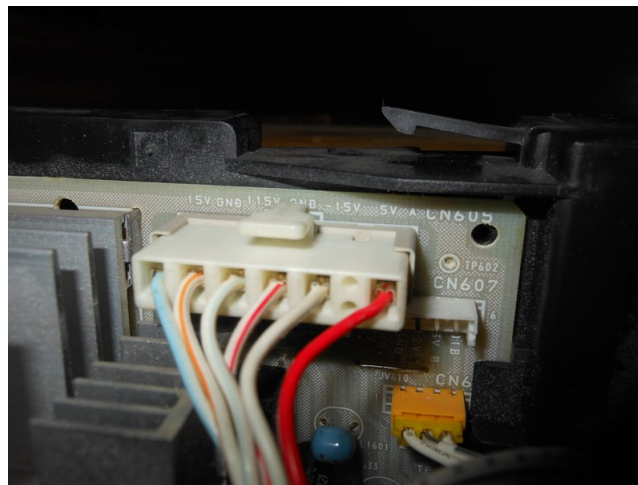
I poked around a bit, but after a few minutes, remembered that voltages should always be checked somewhere early in the repair. Lucky for me, a -15v voltage is showing -25 volts. It being a negative voltage (in my limited knowledge) points to it being for an op amp, and op amps that don't have the right voltage might fail the H and V sync. I will try to fix that and hope there is no other damage.

Figure 2: The Rail is listed as -15V...

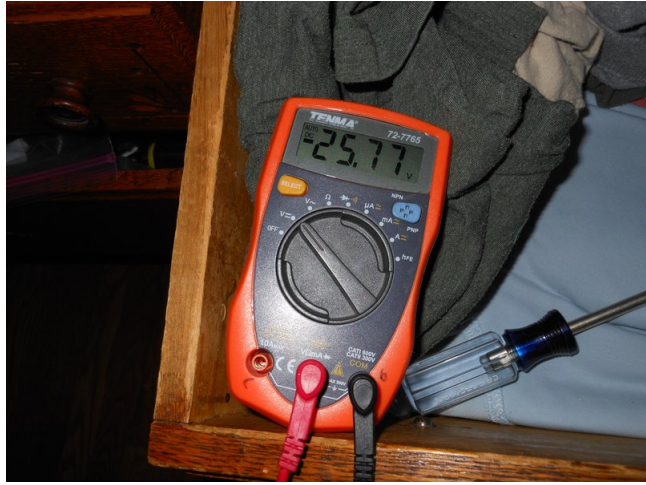
Figure 3: Fault. Later on I moved to a Fluke 27 for this, so please bear with the low quality DMM

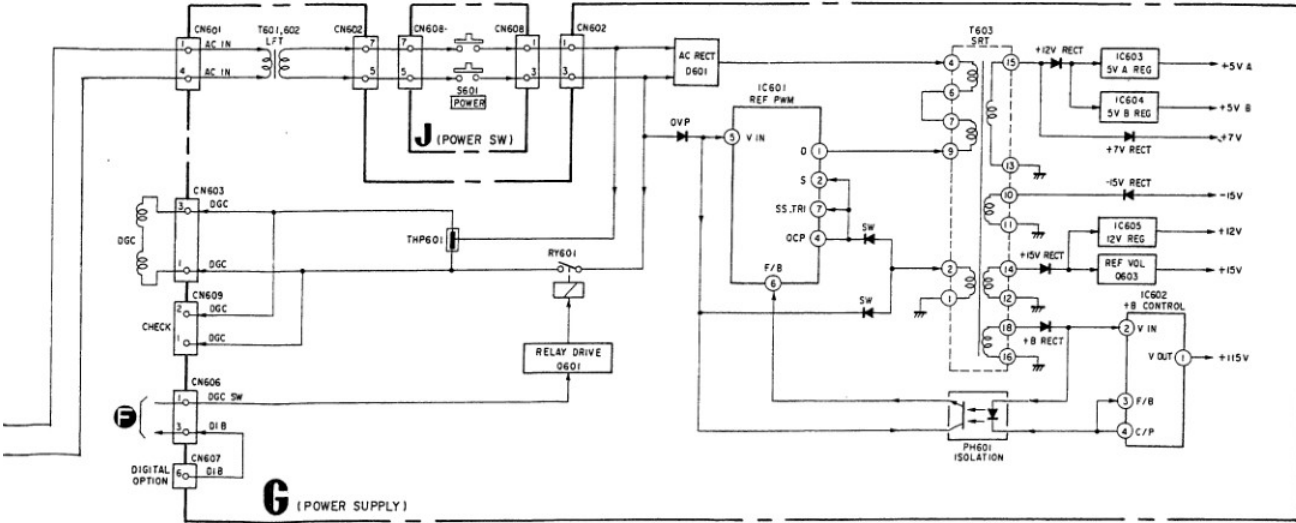
I looked around, and the output from the PWM is fed into a transformer, where it's rectified into a number of different voltages. The service manual tells all of this.

Figure 4: PWM to Transformer to Zener

It appears that the -15V rail (as well as the +7V rail, both have voltages slightly off. I thought at first, the diodes from the block diagram were

zeners (being backwards) but it looks like instead, the problem is before the transformer. I'll have to delve a little deeper to see what is giving an incorrect value.

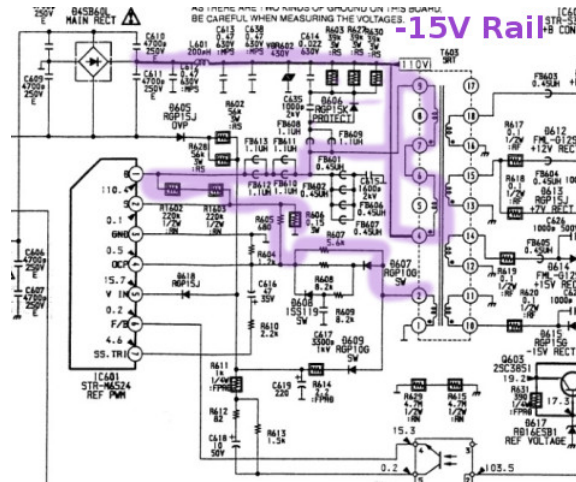
What I know is that there are two rails that are off, the 7V and -15V rails. The 7V rail doesn't appear to be used. I've decided to add in an additional -15V regulator using an LM337, to output 1.5A of -15V. I tried adding another cap on C629, the one of two electrolytics on the -15V rail, but no difference. There are two paths the -15V rail takes in from the mains. One is from the PWM pin B, which has a resistor divider go to S and then down to the pin of the transformer for -15V. One of these resistors might be underspec.

Figure 5: -15V Rail

R605 Measures 380, which may be right (due to it being on board when measuring. it IS close). R604 is .4K (390). Supposed to be 1.2K. But, measuring on board... R607 is .4K again. Seems measuring these in circuit is a losing game. C616 is not a short. R610 is 8.1K. Seems high. It's value should be no higher than 2.2K... Looks like this is a schematic error, as R608 and R609 are the same value resistors and both are similar readings. R610 is in spec. About all I can think, is pulling R604, R605, and R607 and measuring them.

I'm a bit confused whether the test probe measurements are AC or DC. It says 110, which is after a rectifier, (so DC) but I see AC also on this line, and as well, it's going through a transformer, so it must be AC that is coupling, but the AC is 22V, while the DC is 135V or so. Perhaps the fault is near the bridge diode, and with the coupling capacitors nearby... I tried removing them before, but I don't have equipment to test their values. I didn't see any shorts. I give up - I will put in the LM337 and call it a day.
