Weller WSD51 Repair

1 Overview

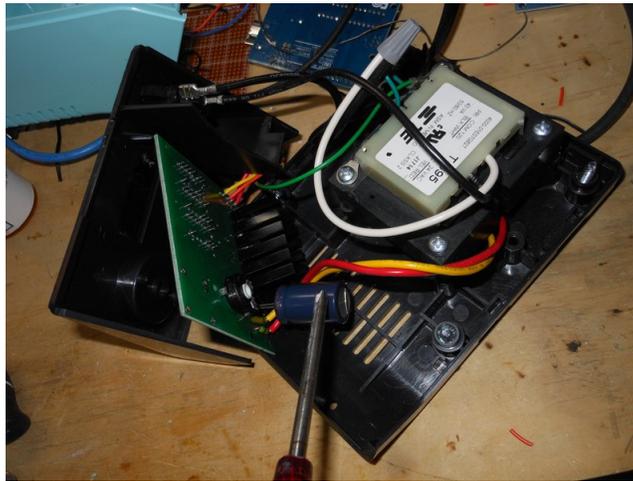
Figure 1: The board is a large power transistor with a Pic to control it. Here I added a capacitor per some online guides, but no dice. It turned out to be a failed iron.

Before shipping, I read online (Guido, creator of Arduino ENC28J60 TCP/IP library and gnu/linux user) that an 888 flashing error was solvable by adding another capacitor to the inside of the board. I tried this without success. In retrospect, his error was different than mine. I didn't have flashing, and my temperature changed between 888 and 902. I also checked the resistance on the iron and didn't get the values I expected, but didn't pursue further. It's under warranty they should fix it.
