Bose Cinemate (Original) Repair

1 Overview

Find out why Bose speakers don't work. User reports possible lightning surge caused damage to device.

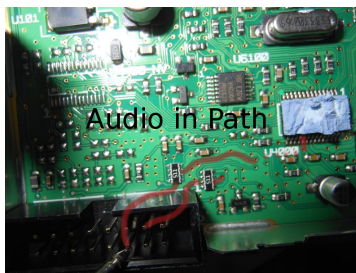
2nd column from last, bottom. On the controller board, beneath the metal case, the two audio signals are fed into resistor dividers, one for each signal. From there they go (see picture) . From there the audio signal goes into that mysterious package, that has no label on it. Probably some ADC. EDIT: I can barely make out it is a Cirrus Logic chip. CS422BA CS4228A One of the pins on the ADC is going up and down. Connected to pin 4 of DSP (not adc). That's serial clk (pin 5 adc). Very slow. Pin 4 of DSP is: RCLK0 RCLK is the serial receive clock. The master clock is an input, PIN 10. It looks like the clock is not there. Data sheet says it must be between 4kHz to 24kHz, about. And the clock signal on Pin 10, is absent. It's like 2 Hz, or something slow. I'm going to trace where the master clock for the ADC comes from. It comes from around 25 or so on the DSP. I marked the DSP. I counted about 26, give or take one. Let's count again. I counted 25 this time. It looks like it goes to ground...? It's the one before ground. I realized I could just count down from continuity from ground. So it's PWM_Event1. Let's boot up the device and see if it ever activates this PWM. It may be that the ADC is fine, and something else is broken. It looks like the ADC communicates with its CLOCK and the DSP during boot up, but goes into a sleep mode. I think it's something else.

Figure 3: Audio In Path

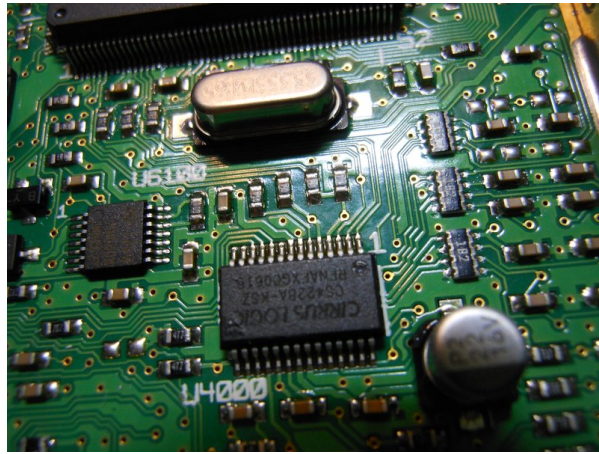
Figure 4: ADC with logo visible: CS4228A
