Bose Cinemate (Original) Repair

Find out why Bose speakers don't work. User reports possible lightning surge caused damage to device.

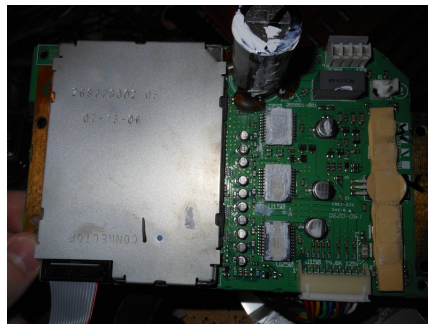
No visible damage inside. Power rails are all clean. Transformer outputs 22V AC. There is a switcher and a linear LDO Vreg both inside a can on the main board powering the ADSP (analog devices, in Woburn here) chip. The clock is OK. CLKIN and XTAL both have 33.33MHz clocks. No visible CLKOUT found. The board is reading external flash at boot, possibly, due to the appearance of such a chip. Checking pins of BMS and BSEL per ADSP data sheet... BMS is high, and BSEL is low, which means in data sheet... When BSEL is low, BMS and BSEL determine input. This appears to mean that BMS is an output, and its reading from external memory. There is a JTAG on the bottom of the board. I don't have the appropriate reader. There is a necessary delay after powering off the board, you have to wait for the caps to discharge, before powering back on. I found this by watching the Output enable pin of the flash on the scope (which seems to be working and apparently the flash is being read at bootup by the ADSP CPU). If you unplug power, and don't wait for the power to drop (about 5-10 seconds) it will not fully restart. The online docs say to wait one minute, hehe. That's why.

Figure 1: Main Board. CPU / ADC is under shield.

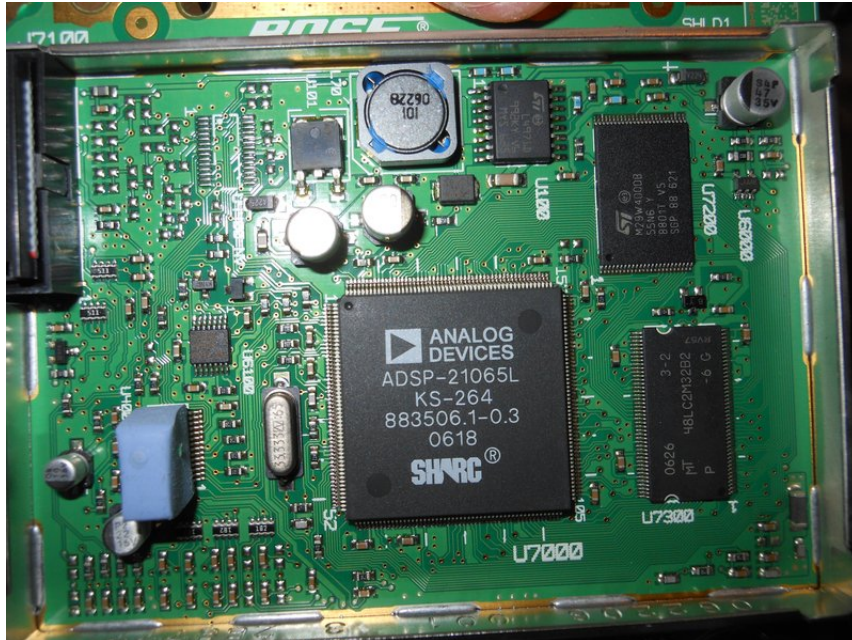
Pin DQ0 on the flash is constantly changing, in a set pattern. Perhaps flash is being accessed regularly? G (bus read) is normally high, but low during

periods at boot. Based on data sheet, G is high and W down, when writes occur, separately G is down when reads occur. Write is pin 11. Write is normally high, and goes down briefly during boot up sequence (much less than the G pin). Based on all this, I suspect the flash is operating OK, without checking jtag.

Figure 2: Main CPU board under can. Starting from 12 o'clock going clockwise, Linear and Switching power regulator, Flash, RAM, ADSP CPU (SHARC), ADC (under blue).

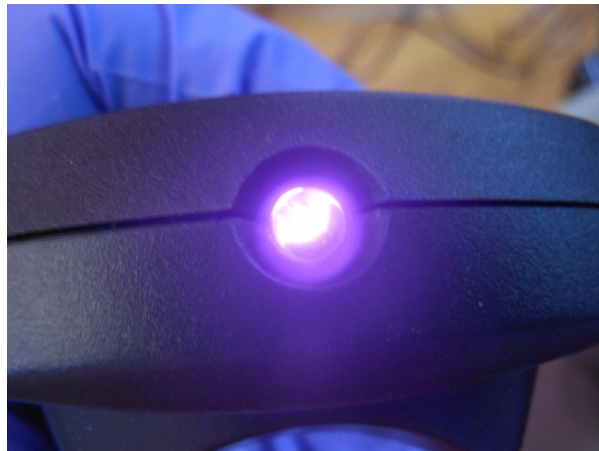
Checked the Remote control by viewing it via a digital camera. It is working.

Figure 5: IR is normally invisible, however my digital camera picks it up. A Quick way to test IR is to take a picture. Alternatively, you can probe the diode leads with an oscilloscope.

Diode fixed it. 38KHz model from Radio Shack. Pinout was identical. There is a youtube video online that covers this repair also.
