Car Transmission Repair

Steak Electronics

1 Work Log

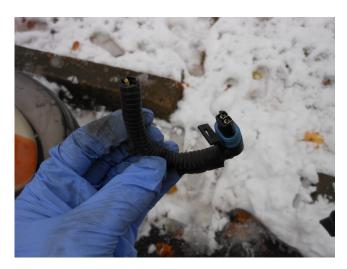
Figure 1: Cut off the connector at one end, so I can attach wires to it. This is what connected to the transmission

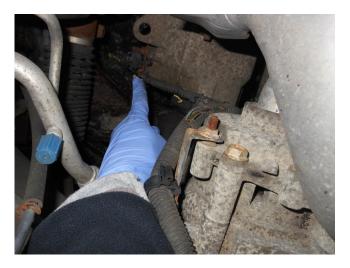
Figure 2: Wires visibly chewed here

The bunny had chewed up two of the wires. What happened, is that two sense wires (?) to the transmission had failed, and as a result, the car was unable to control the transmission. A mechanic later implied that animals chewing wires was not uncommon. I was even fortunate enough to run into a bunny stuck in the car. Perhaps I caught him in the act.
