CL Repair Bose Cinemate

Objective: Find out why Bose speakers don't work. User reports possible lightning surge caused damage to device.

Bose Cinemate 1

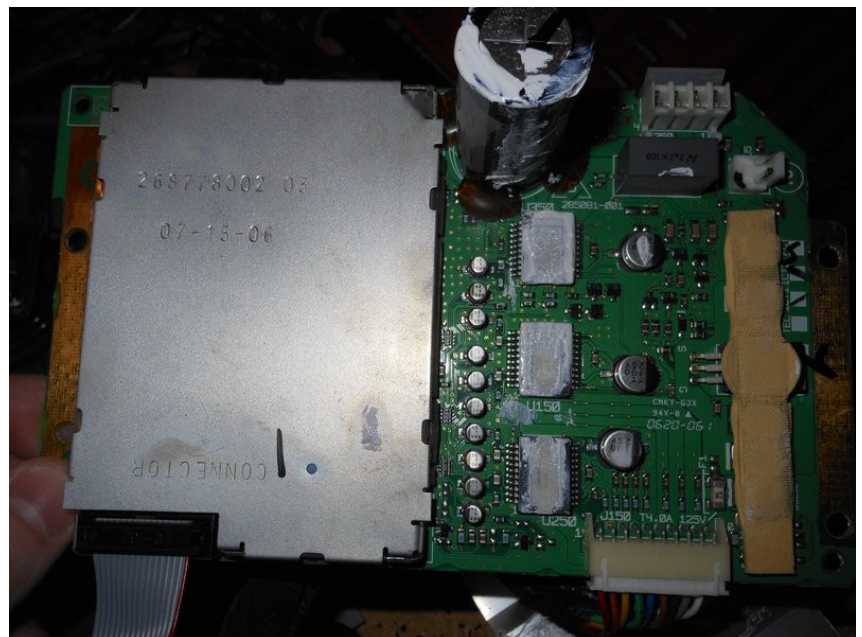
Main Board

Pin DQ0 on the flash is constantly

changing, in a set pattern. Perhaps flash is being accessed regularly?

G (bus read) is normally high, but low during periods at boot. Based on data sheet, G is high and W down, when writes occur, separately G is down when reads occur. Write is pin 11. Write is normally high, and goes down briefly during boot up sequence (much less than the G pin). Based on all this, I suspect the flash is operating OK, without checking jtag.

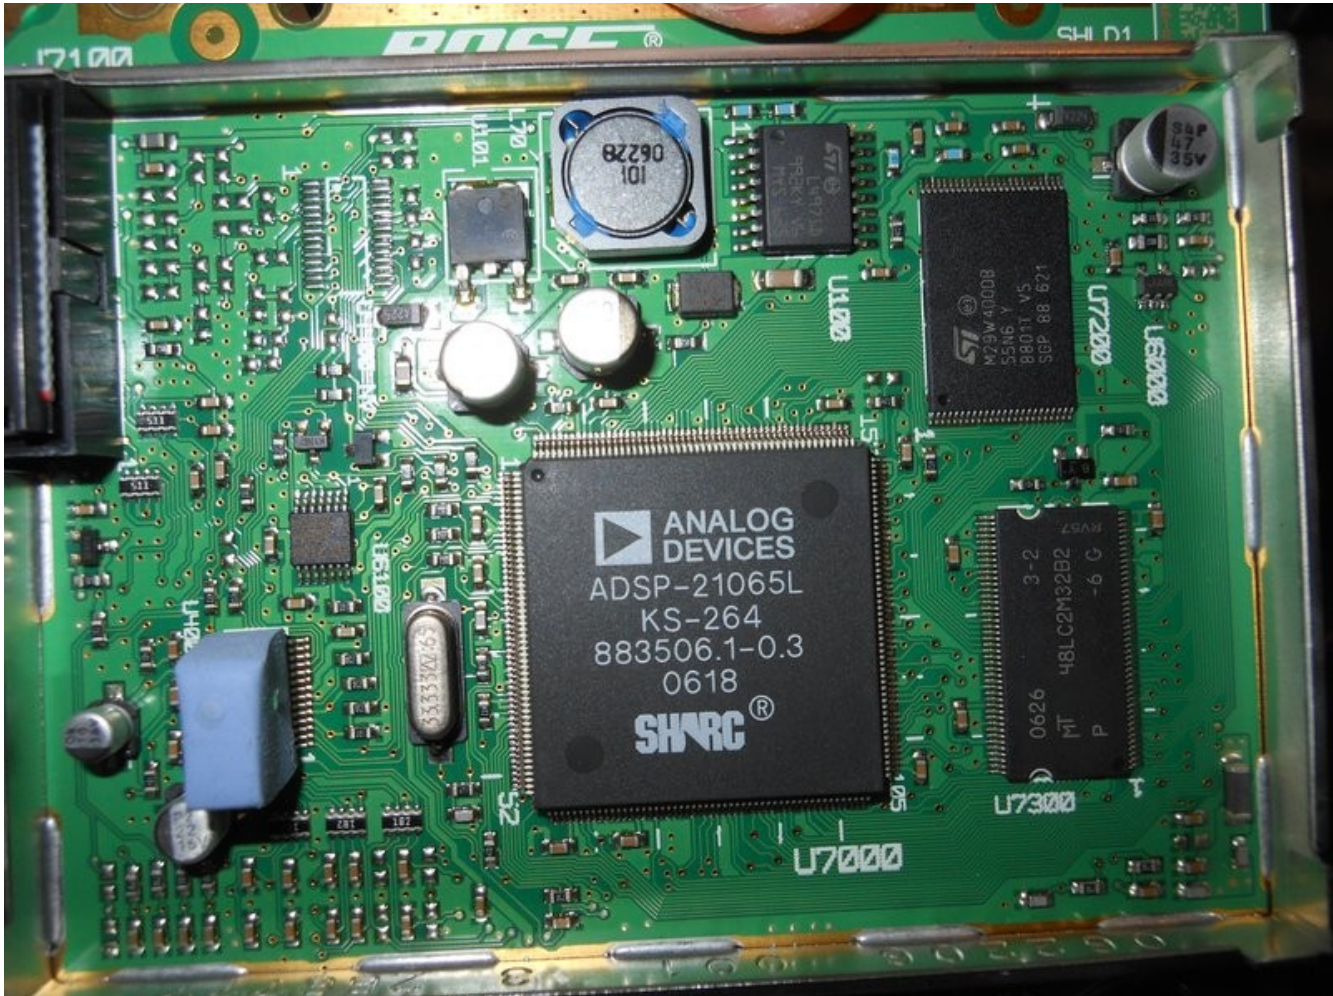
Main CPU board under can. Starting from 12 o'clock going clockwise, Linear and Switching power regulator, Flash, RAM, ADSP CPU (SHARC), ADC (under blue).

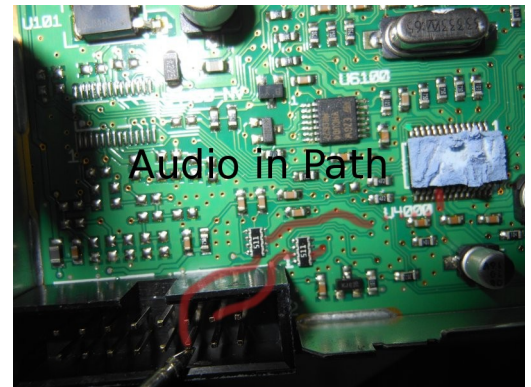
signals are fed into resistor dividers, one for each signal. From there they go (see picture) . From there the audio signal goes into that mysterious package, that has no label on it. Probably some ADC. EDIT: I can barely make out it is a Cirrus Logic chip. CS422BA
CS4228A

One of the pins on the ADC is going up and down. Connected to pin 4 of DSP (not adc). That's serial clk (pin 5 adc). Very slow. Pin 4 of DSP is: RCLK0
RCLK is the serial receive clock.

The master clock is an input, PIN 10. It looks like the clock is not there. Data sheet says it must be between 4kHz to 24kHz, about. And the clock signal on Pin 10, is absent. It's like 2 Hz, or something slow. I'm going to trace where the master clock for the ADC comes from. It comes from around 25 or so on the DSP. I marked the DSP. I counted about 26, give or take one. Let's count again. I counted 25 this time. It looks like it goes to ground...? It's the one before ground. I realized I could just count down from continuity from ground. So it's PWM_Event1. Let's boot up the device and see if it ever activates this PWM. It may be that the ADC is fine, and something else is broken. It looks like the ADC communicates with its CLOCK and the DSP during boot up, but goes into a sleep mode. I think it's something else.

ADC/DAC with logo visible. CS4228A
